THESIS

THE RESPONSE AND FAILURE MECHANISMS OF CIRCULAR METAL AND COMPOSITE PLATES SUBJECTED TO UNDERWATER SHOCK LOADING

ROBERT A. JONES

March 1990

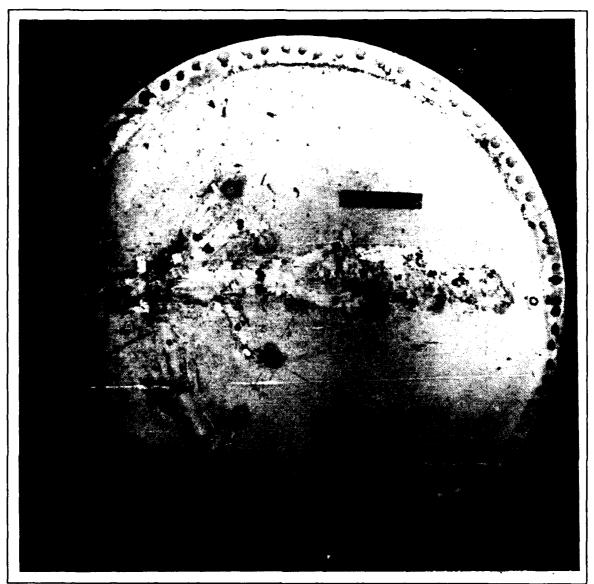
Figure 24. The Aluminum Panel From Test T1W.

The water backed test panels showed little or no damage from the underwater explosions regardless of the charge weight used. As shown by Figure 24 the aluminum plate of test T1W was unaffected by the shock wave produced by five pounds of TNT. No noticeable deformation was noted in the composite plates subjected to the shock from five pounds of TNT in test T2W and to the shock from ten pounds of TNT in test T3W. The

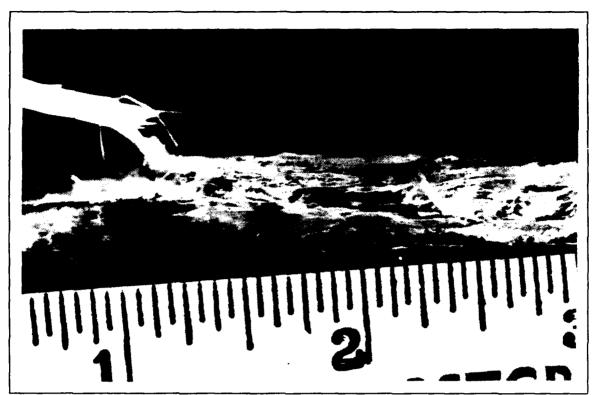
oriented narrow strips of localized matrix rupture that appeared to initiate at the outer edge of the panel and to propagate toward the center of the panel. The fiber rovings in these regions of matrix failure appeared to have buckled away from the central layers of the panel. An edge on view of each of the failure regions showed that the matrix failure occurred at an angle to the thickness of the panel as illustrated by Figure 30. The visual evidence suggests that the brittle matrix material failed due to compressive stress imposed in the circumferential direction.

Figure 30. Edge View of a Matrix Failure.
